Mt Coot-tha Local Residents Second Whistle-Blower Report: Blast Dust is Never Measured

11th September 2019

Complaint Title: Mt Coot-tha Quarry regularly emits huge amounts of totally unmeasured & unaccounted thick silica blast dust clouds which regularly and persistently enters the KRA-42 Separations Areas, Residential Areas, Mt Coot-tha Parklands and Botanical Gardens.

Complaint Authors: The Mt Coot-tha Local Residents (MCLR). These are the residents living between Birdwood Tce and the Brisbane City Council (BCC) Mt Coot-tha Quarry (MCQ), and are the originators of the 2018 DES complaint CTS32131/18.

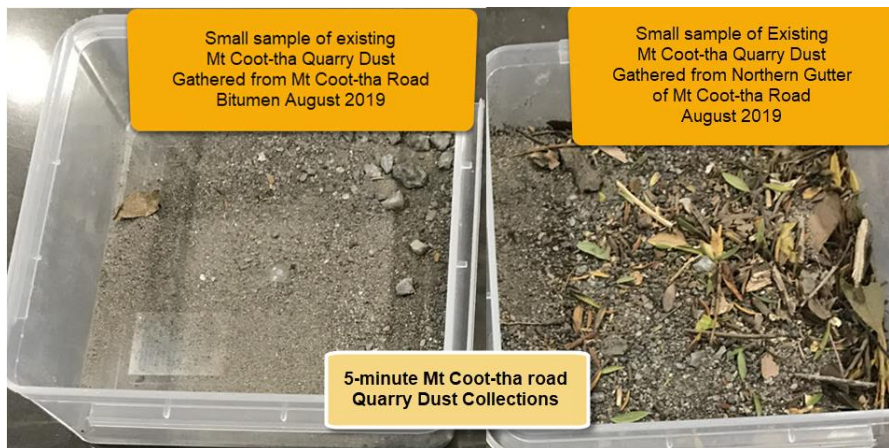
7. The vague MCQ descriptions in the unreadable dust monitoring map demonstrates that the DES Compliance manager was generally unaware of the poorly placed dust collection devices.
